Navigation Systems Research Program

Underwater Inspection of Navigation Structures with an Acoustic Camera

August 2013

Final report

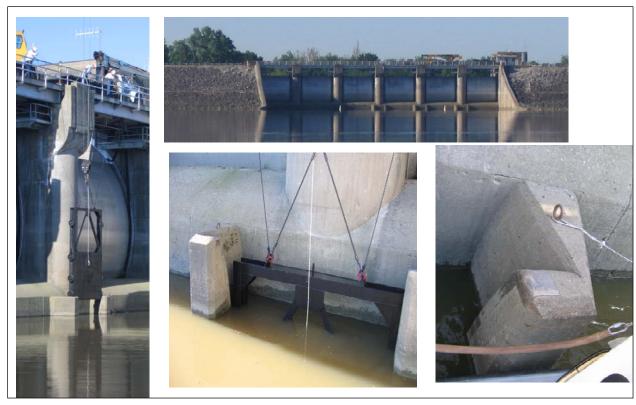
Figure 4-35. Steel service gate with binding issues.
